This report summarizes the details and results of various studies which have been performed as part of the Connecticut Department of Transportation's (CTDOT) planning process for the Reconstruction of Interstate 84/CT Route 8 Interchange Project (the I-84 Mixmaster Reconstruction Project, the Project). The Project has been initiated by the CTDOT to enhance safety, improve structural conditions, and correct operational and geometric deficiencies of the Interstate 84 (I-84) and Route 8 "Mixmaster" interchange and larger transportation network in the Waterbury area.

The content of this Analysis, Needs, and Deficiencies Report is primarily intended to guide the development of conceptual Project improvements. The future "no build" scenario will be used as a benchmark condition for comparison and evaluation of improvement concepts. This report purposefully does not discuss or consider Project improvement concepts.

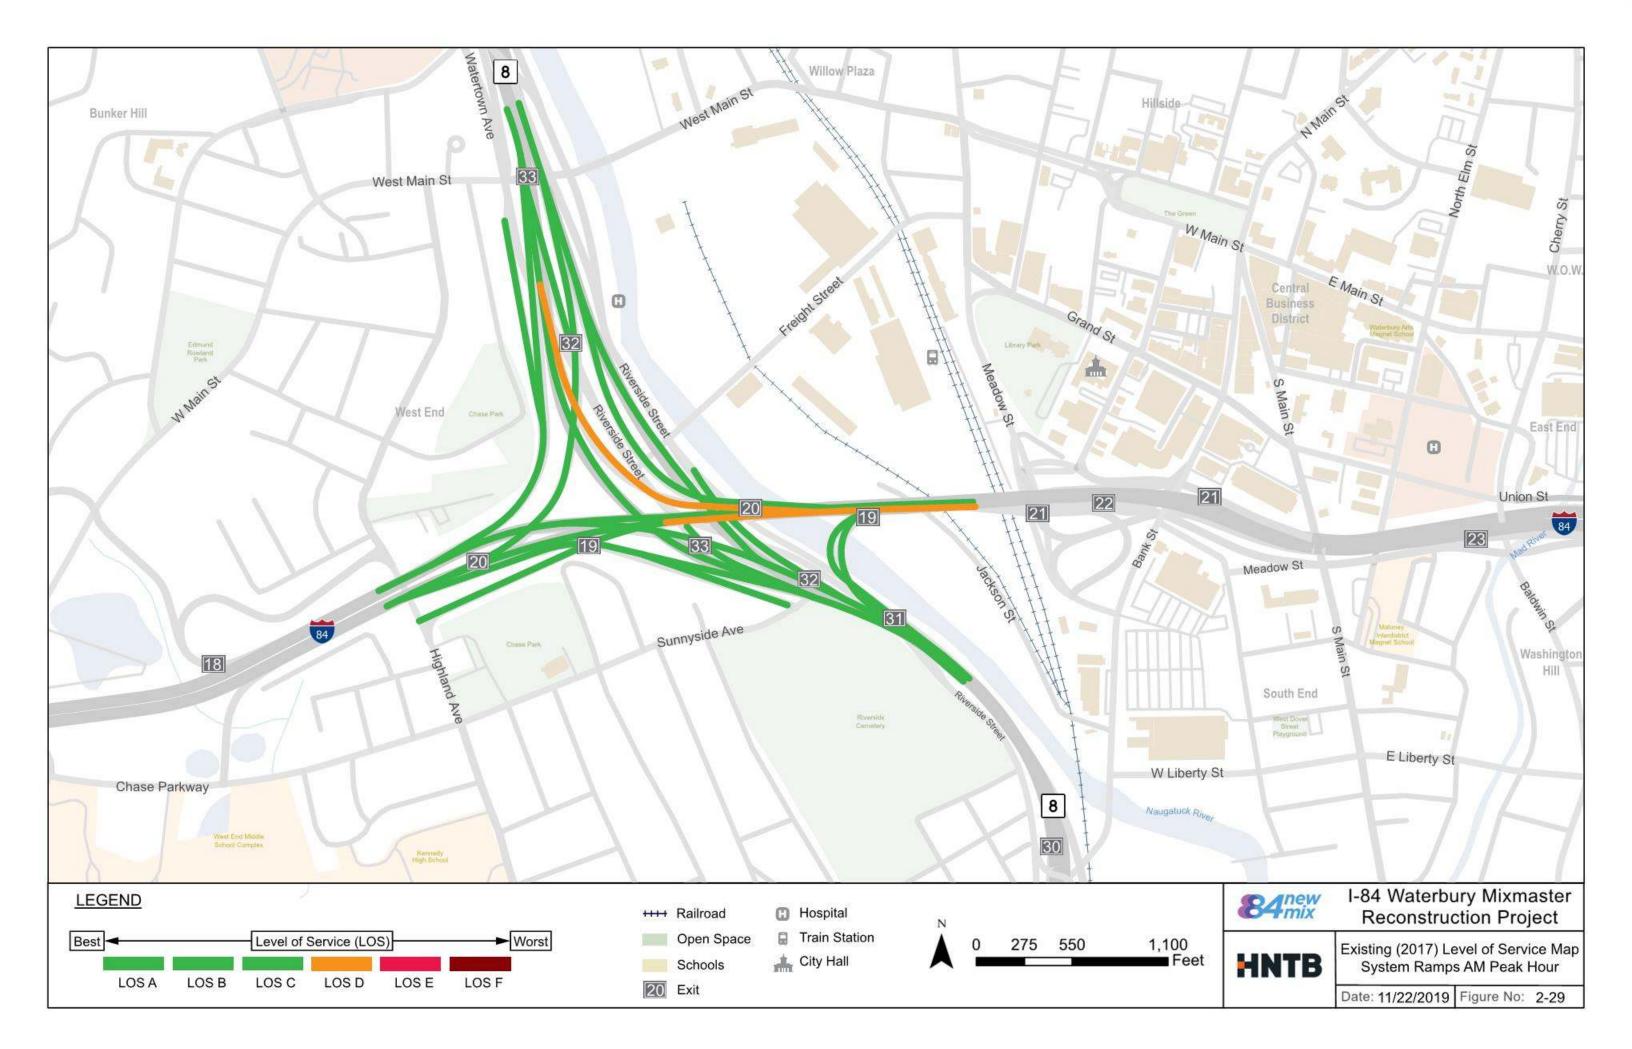
Figure 2-29 and *Figure 2-30* represent the LOS results for system ramps.

As shown in **Figure 2-29**, all system ramps are estimated to operate at acceptable levels of service during the AM Peak Hour. **Figure 2-30** shows that all system ramps are estimated to operate at acceptable levels of service except for the I-84 Westbound System Ramp to Route 8 Northbound which experiences a higher than acceptable density, operating at LOS E.

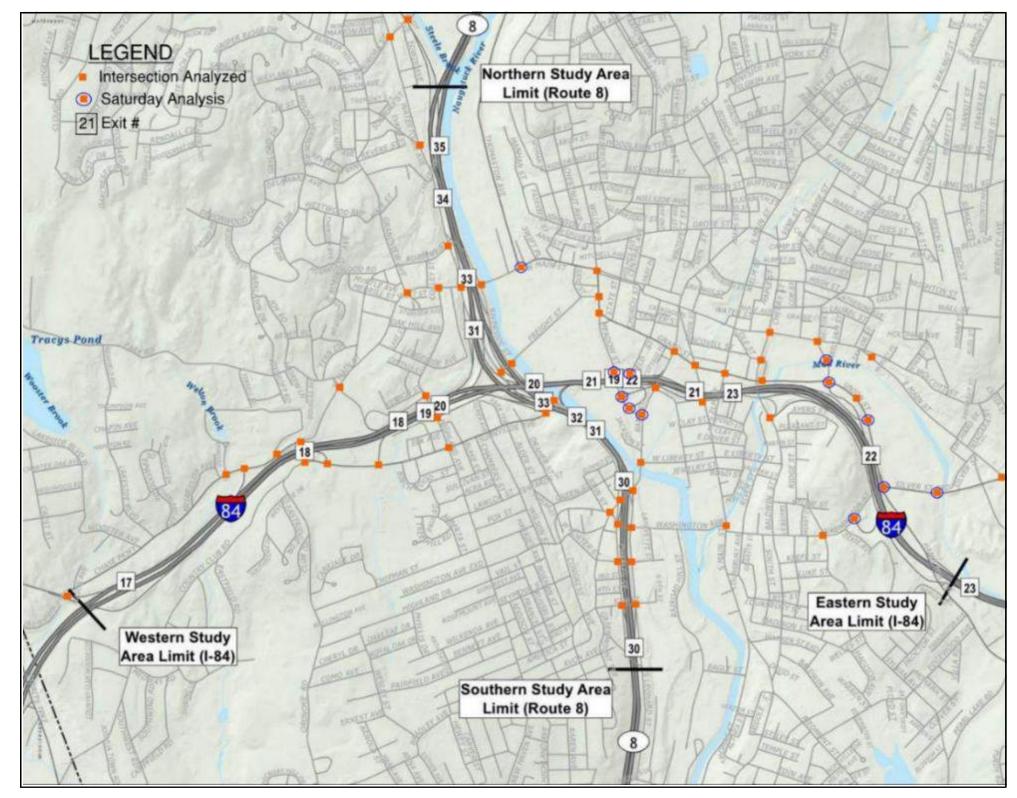
Figure 2-31 Analyzed Arterials and Intersections Map

- 1. Highland Avenue at Chase Parkway and Sunnyside Avenue
- 2. Washington Street at Interstate 84 Eastbound Off Ramp (Exit 23)
- 3. Watertown Avenue at Aurora Street
- 4. Route 73 at Watertown Avenue and Huntingdon Avenue
- 5. Route 73 at Aurora Street and East Aurora Street

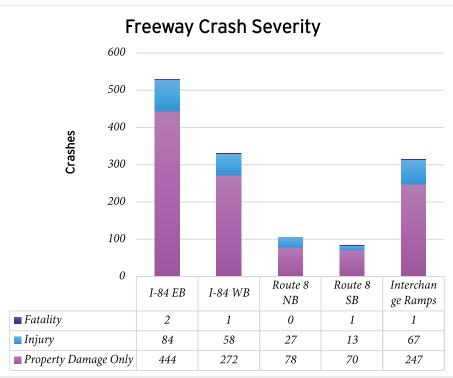
A summary of mainline crash statistics by severity is provided in the following figure.

The overall proportion of rear-end crashes (46 percent) seems consistent with observed congested flow conditions where vehicles may need to stop suddenly. Specifically, approximately 60% of I-84 eastbound crashes were rear-end type which corresponds to the higher vehicle density and worse capacity performance observed for eastbound I-84 noted in Section 2.3 Existing Traffic Operations.

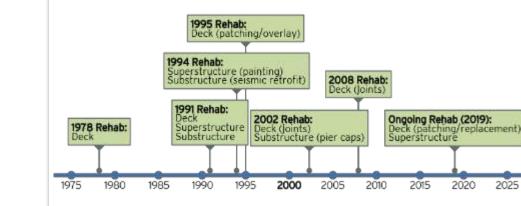
Figure 2-57 Previous Bridge Rehabilitation Projects

Deck						Superstructure					
Bridge No.	Feature Carried	Waterproofing Membrane	Deck Joints	Deck Repairs	Deck Replacement	Parapet Replacement	Parapet Modifications	Steel Repairs	Superstructure Strengthening	Bearing Replacement	Crack Repairs	Beam End Repairs and Painting	Substructure Repairs
03190A	RTE 8 NB	~	~		~	~		~	~			~	~
03190B	RTE 8 SB	~	~		~	~	~	~	~			~	~
03190C	System Ramp	~	~	~			~	~		~		~	~
03190D	System Ramp	~	~	~			~	~		~		~	~
03190E	Service Ramp	~	~	~			~	~				~	~
03190F	System Ramp	~	~	~			~	~	~			~	~
03191A	I-84 EB	~	~	~			~	~	~		~	~	~
03191B	I-84 WB	~	~	~			~	~	~		~	~	~
03191D	System Ramp	~	~	~			~	~	~			~	~
03191E	System Ramp		~	~			~	~	~			~	~

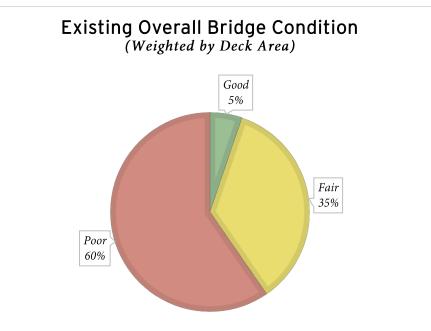
Figure 2-60 Existing Major Bridge Component Conditions

Existing physical conditions of the studied bridges are also summarized by major components in Figure 2-60.

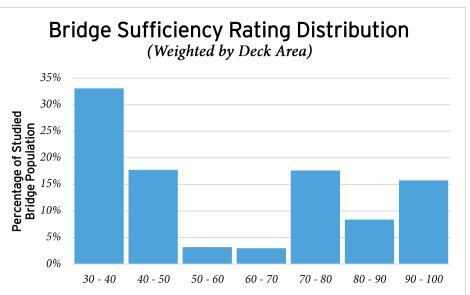
Figure 2-63 Bridge Sufficiency Rating Distribution

A sufficiency rating is a value from 0 to 100 percent which indicates a bridge's sufficiency to remain in service. It is calculated with an FHWA prescribed formula that considers "essentiality for public use" in addition to condition rating, load rating, and appraisal rating data (see previous sections). Sufficiency ratings are used primarily as a planning tool for prioritization of bridge projects.

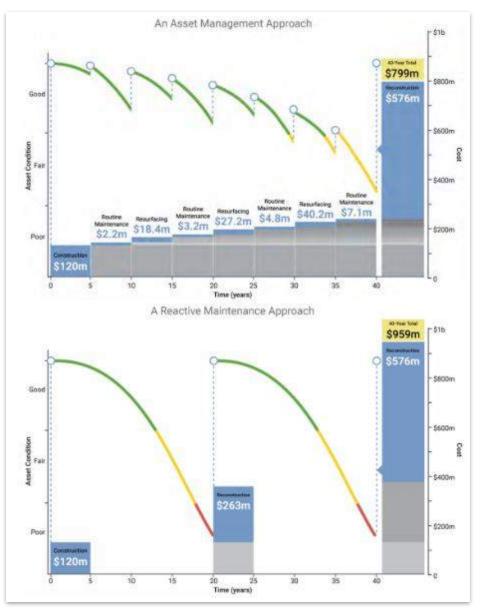
Figure 3-19 Proactive Maintenance vs. Reactive Maintenance ⁵

Forecasts of study area bridge conditions were developed for the year 2045 based on engineering judgment⁴, planned rehabilitation projects, and their existing physical condition.
